Troubleshooting “ GP-2000 ”

Technical Knowledge

K C MAHANAKORN CO.,LTD.

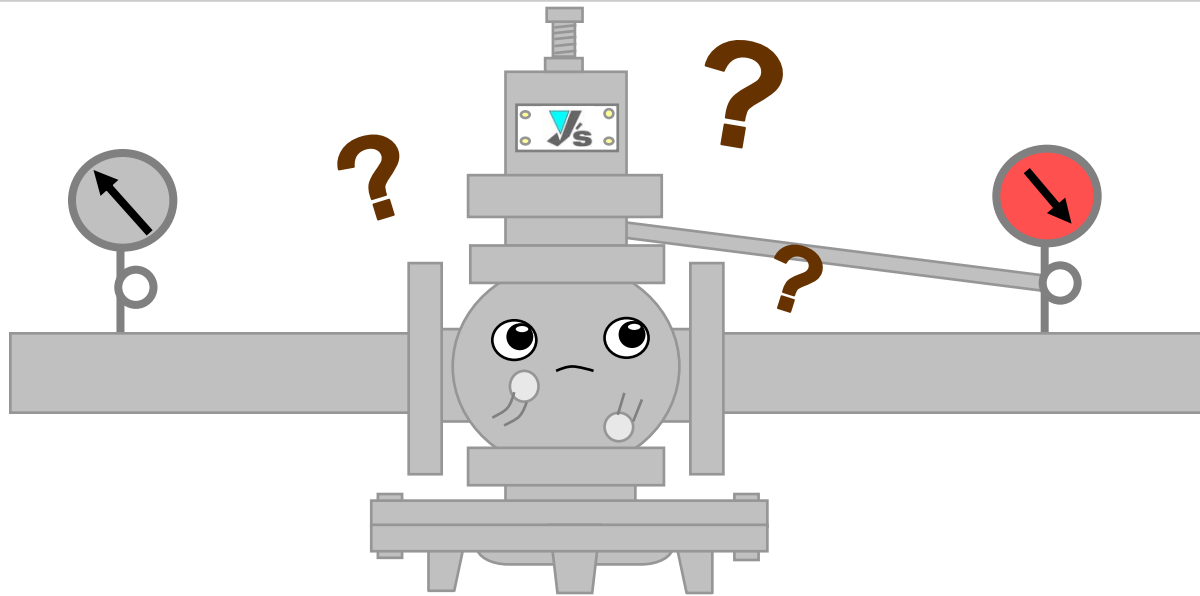
Problems caused by other factors “Outlet pressure increase / decrease”

Pressure gauge is broken

Replace the pressure gauge

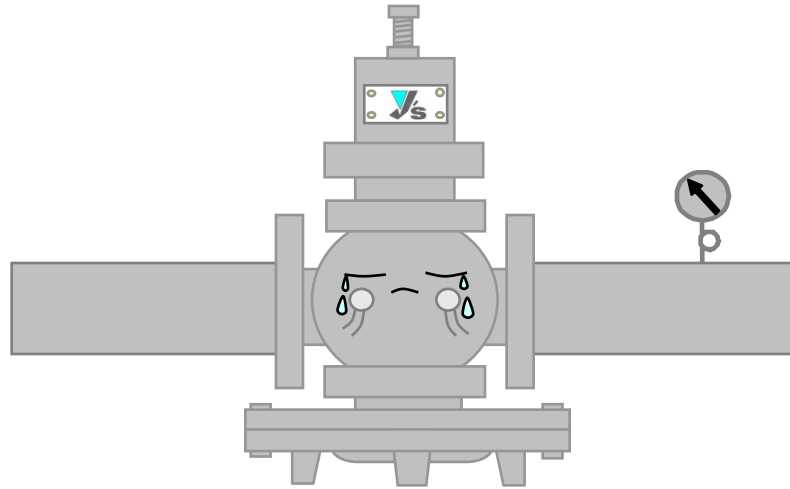
- *Inlet : 0.5MPa, pipe size 50A
- Outlet : 0.2MPa, pipe size 50A
- Steam capacity : 600 kg/h

Pipe size at outlet side is too small !!

*0.5MPa Pipe size 50A, Velocity : 35.6 m/s

*0.2MPa Pipe size 50A, Velocity : 130 m/s

High velocity leads to have pressure loss

Velocity : 20 – 40 m/s

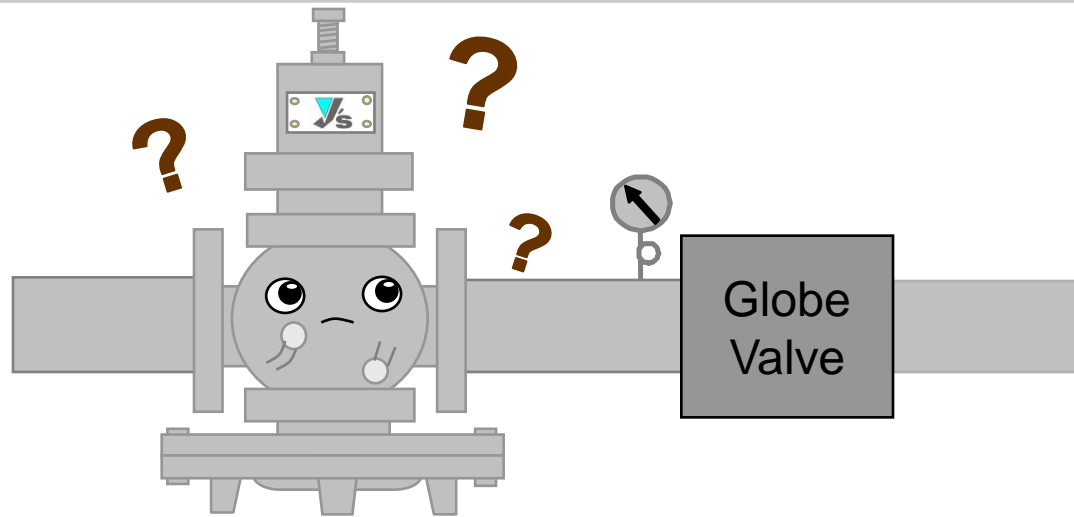
- *Decrease in outlet pressure
- *Globe valve is installed after PRV

The pressure loss is caused by Globe valve.
The flow capacity of globe valve was cannot handle the steam capacity.

- *Should install gate valve which has less pressure loss comparing to globe valve.
- *Select proper size of valve after PRV.

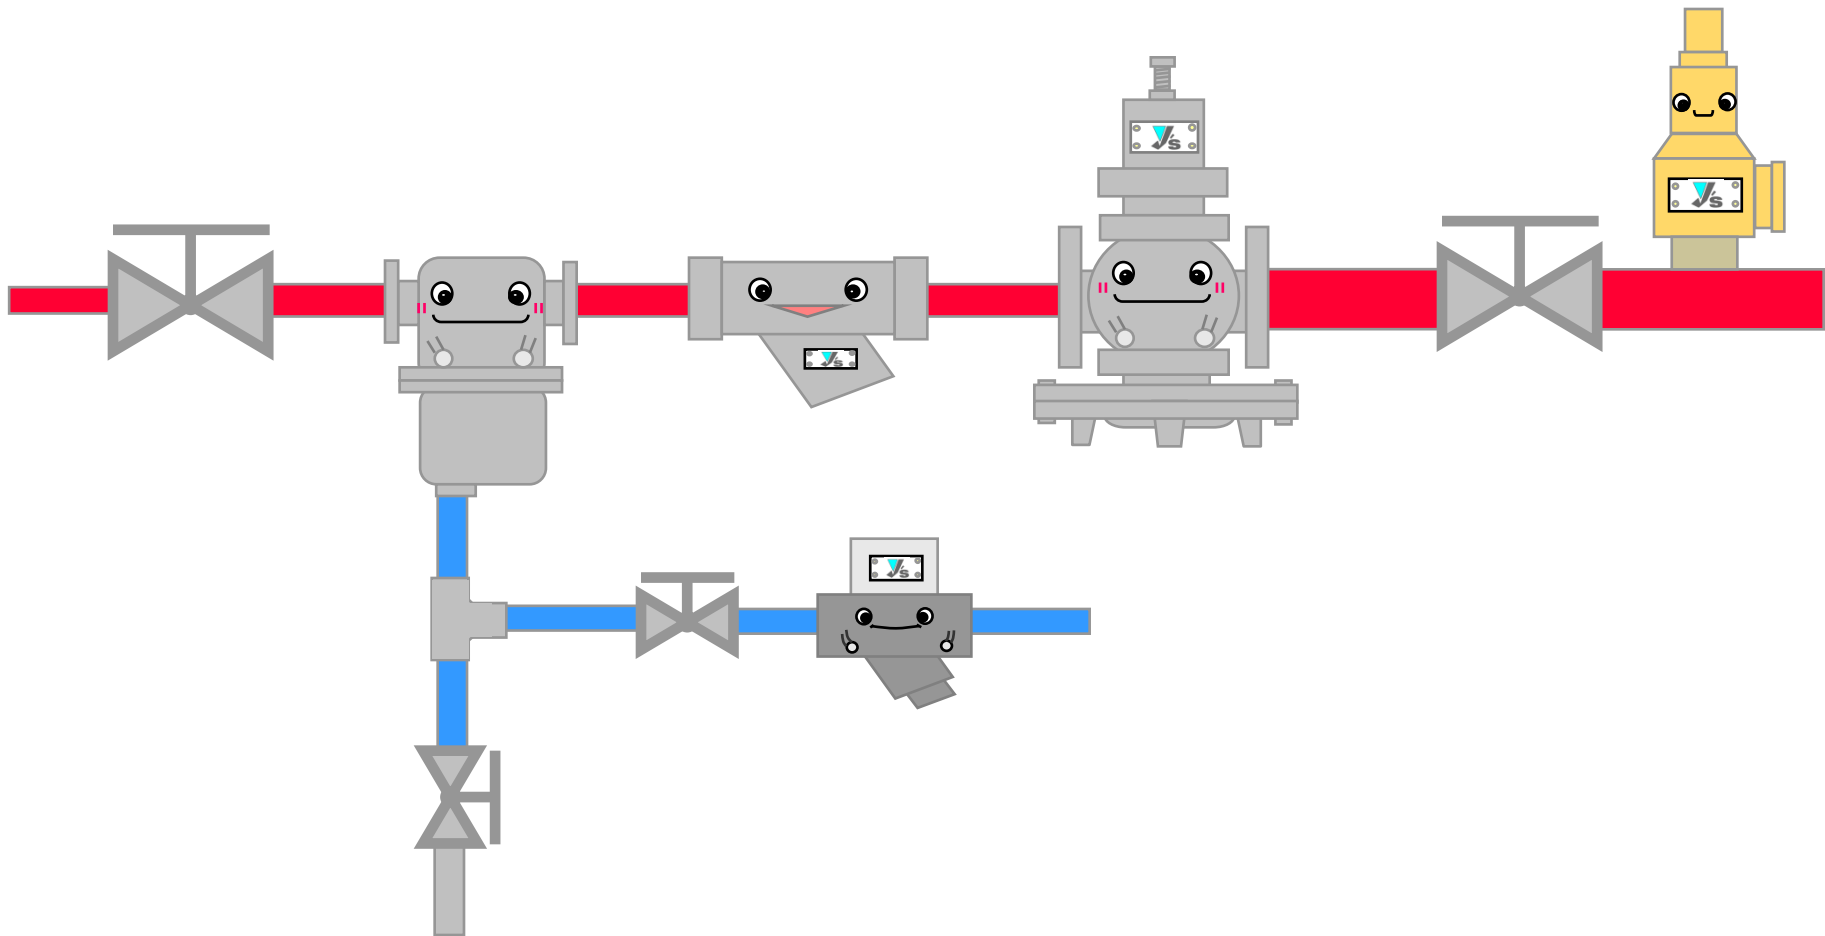
To avoid “Water hammer”

Proposal : Installing separator and steam trap

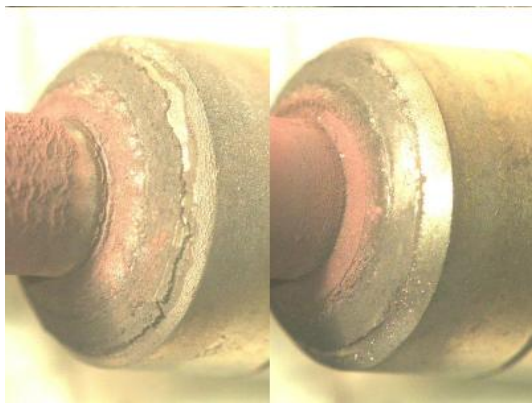
Increase in outlet pressure!!
because pilot valve force to open by scale

Leakage because valve cannot close completely

Pilot valve

Have to change pilot assembly

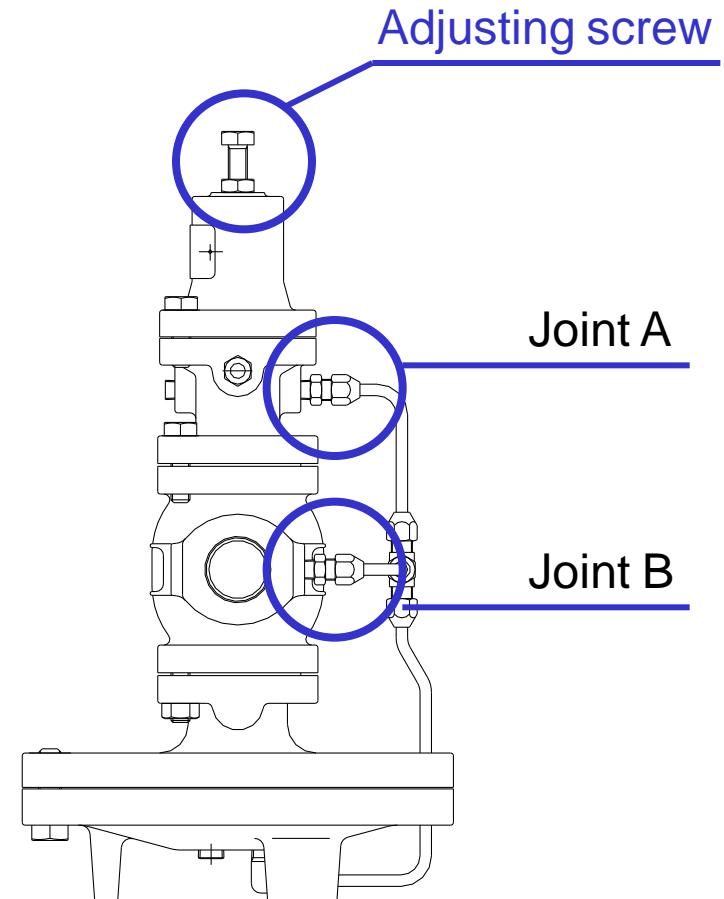
Step 1 : loosen lock nut of adjusting screw and loosen screw until feel the load has been removed.

Step 2 : Loosen joint A & B and slowly open stop valve a little. Inspect whether steam leaks out of joint A & B.

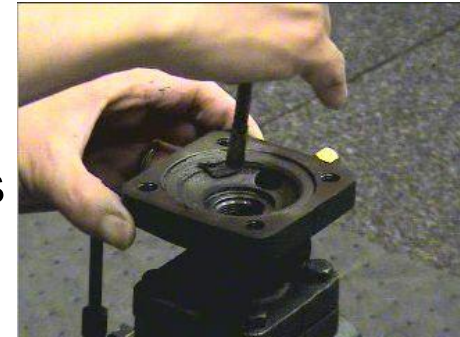
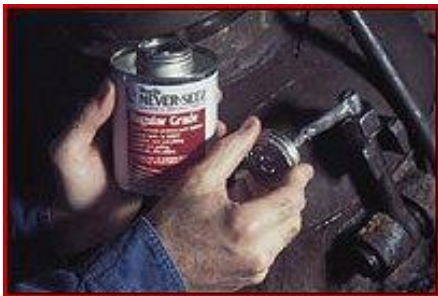
Regular Grade Anti Seize

The "original" anti-seize compound and extreme pressure lubricant formulated with copper, graphite, aluminum and other ingredients to protect metal parts against rust, corrosion and seizure up to 1800°F. Fine metallic and graphite particles in special grease protect parts even in high heat, high pressure and corrosive environments. Ford ESE-M12A4-A, Garrett Engine Div. PCS5724, Pratt & Whitney PWA 360523-2 and tested to MIL-A-907.

Step 2: Apply liquid sealant to the periphery of the bottom sealing surface of pilot diaphragm.

(NEVER-SEEZ standard grade, made by BOSTIC is recommended as a liquid sealant).

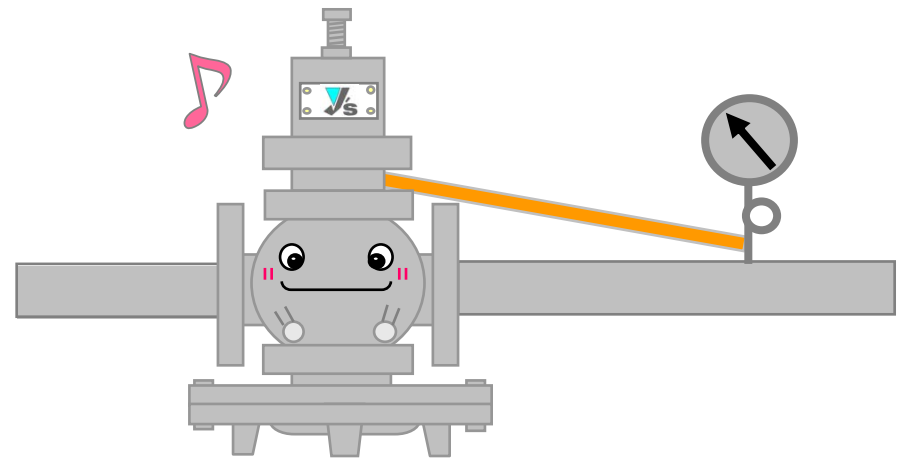
Without external sensing pipe, the pilot valve keeps opening by the adjusting spring force. Pilot valve will not sense and adjust the reducing pressure.

Install the external sensing pip.

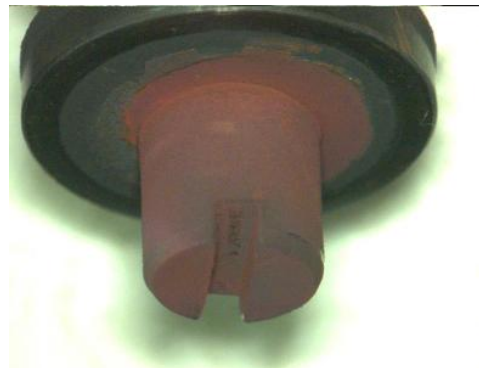
Outlet pressure cannot control!!
because defect on pilot valve

Leakage will be caused and valve cannot open completely because of dirt.

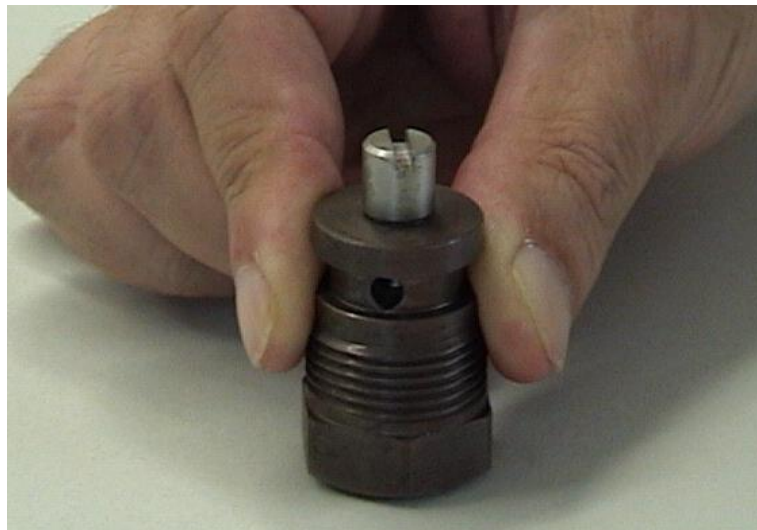
Step 1 : Turn the pilot valve assembly upside down and place it on a table.

Step 2 : Hold valve seat by fingers, depress the assembly strongly and check whether valve seat moves.

Change the parts as pilot assembly

*Please also change pilot diaphragm at the same time.

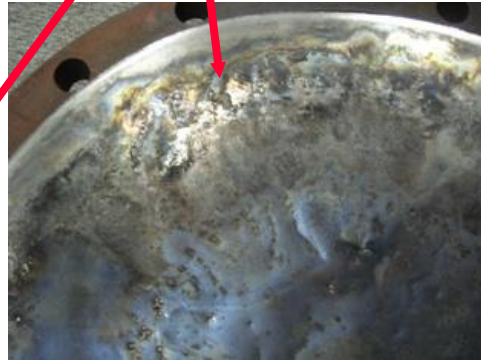
Scale moves into diaphragm case

Equalizing line

*Please make sure strainer (60 – 80 mesh) is installed before PRV.

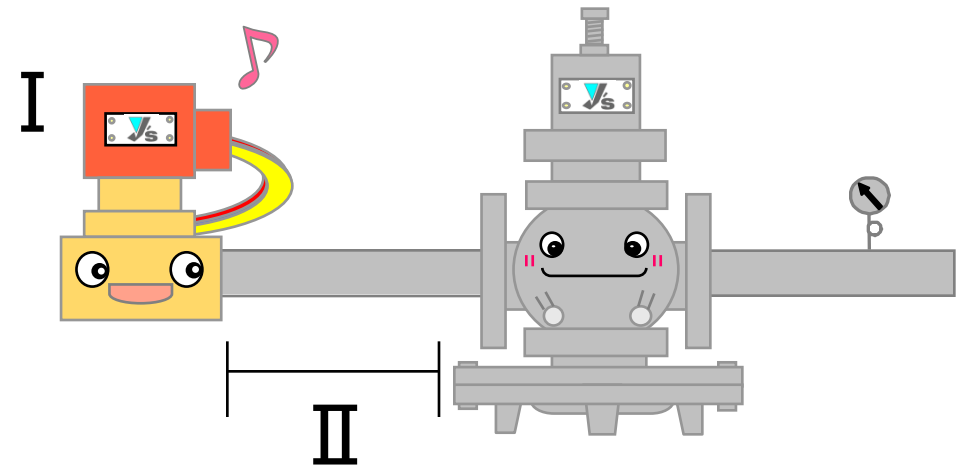
2: Water hammer

- I . On-off valve should be installed in front of PRV
- II . Proper location (more than **3M** away from PRV)

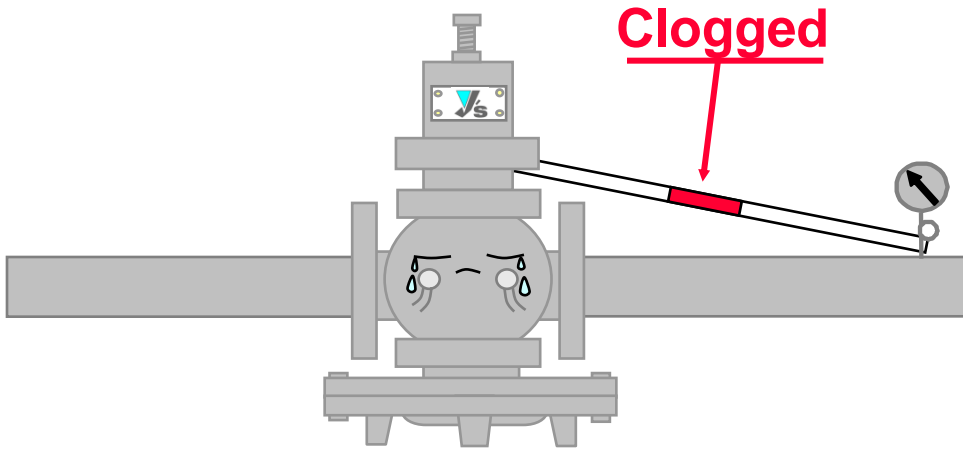
The pressure inside of external sensing pipe cannot escape because of scales,

Lots of scales inside of the piping

Blow inside of the external sensing pipe with compressed air.

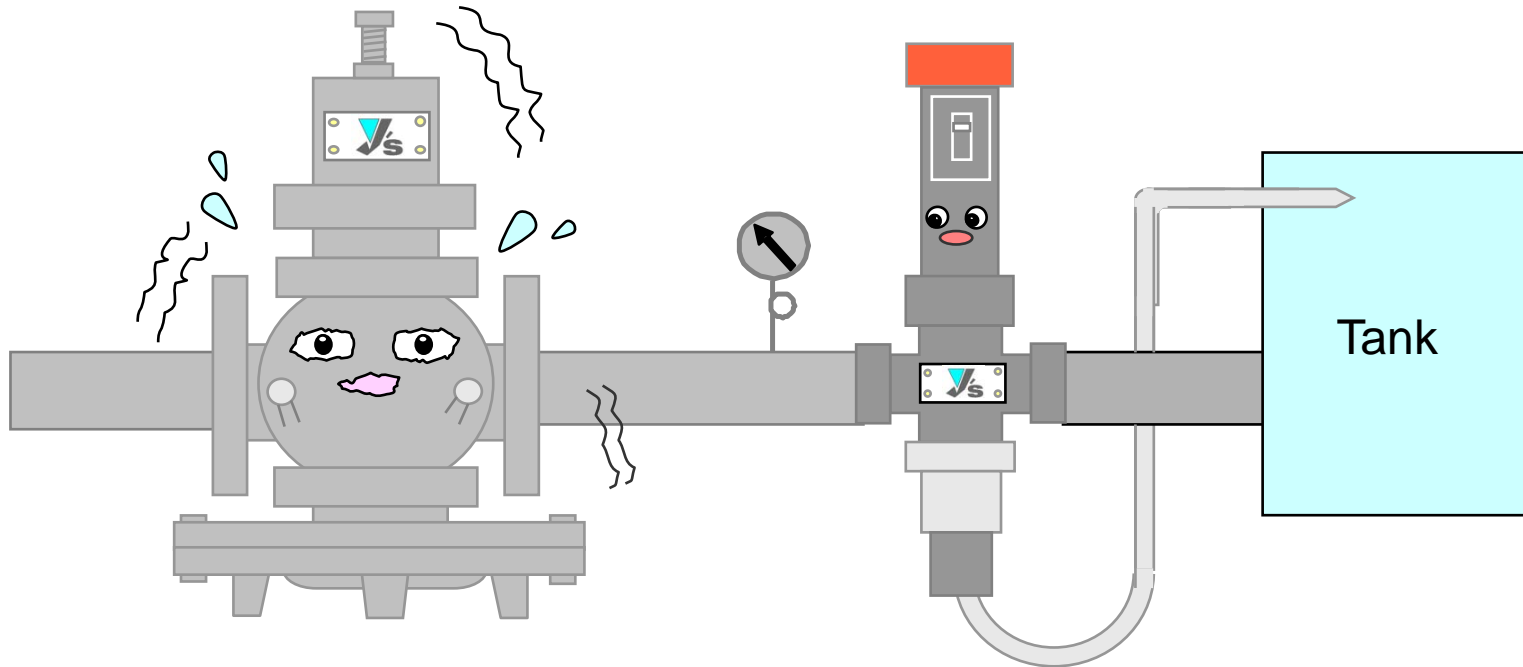
Vibration problem

*Flow rate: 30 kg/h

*GP-2000 25A & OB-30 25A

*P1: 0.4MPa, P2: 0.2MPa

*Rated flow of GP-2000 : 600kg/h and
Flow rate : 30kg/h is only 5% of rated flow.

*When the flow becomes lower than 30 kg/h
vibration is occurred.

- *Should install proper size of PRV.
- *Installing GP-1000 15A or GD-30 15A to solve the problem.
- *Select proper size of the valve between 30 to 80 % of rated flow.
